Inspection Report Minerals Regulatory Program October 21, 2010

Mine Name: Flower Patch Quarry	Permit Number: S/039/0019
Operator Name: Bown Stone Products, Inc	Inspection Date: 10/13/2010
Inspector(s): Brett Gregory for Lynn Kunzler	Time: 1:30 pm
Other Participants: Ken Bench (Sanpete County Assessor)	Mine Status: Active

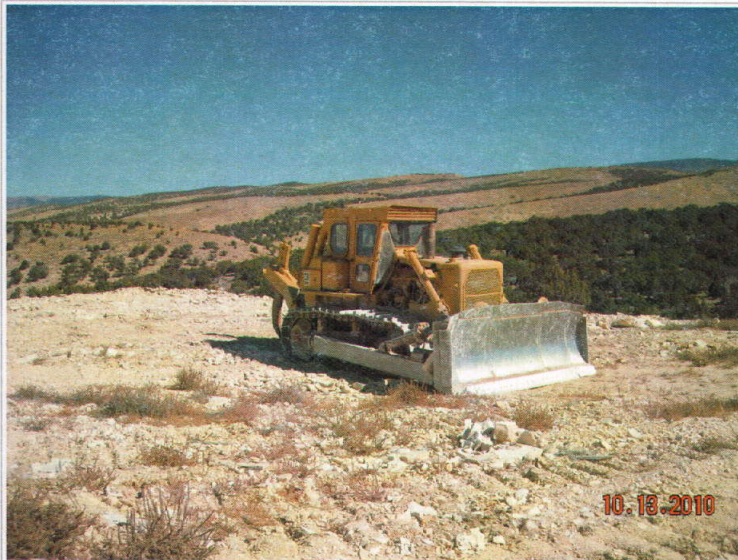
Equipment left on site from the reclamation.

The operator has successfully finished at least half of the reclamation required. Once the lower half of the hillside is graded and contoured to match the surrounding terrain, the operator may submit for a partial bond release. The car wreckage, miscellaneous equipment, pallets of limestone, and garbage should be removed from the site. Any seeding for revegetation should be done as soon as possible to allow for the minimum of three growing seasons required under rule. The Division will periodically review the success of the reclamation work before the site is considered for full release.

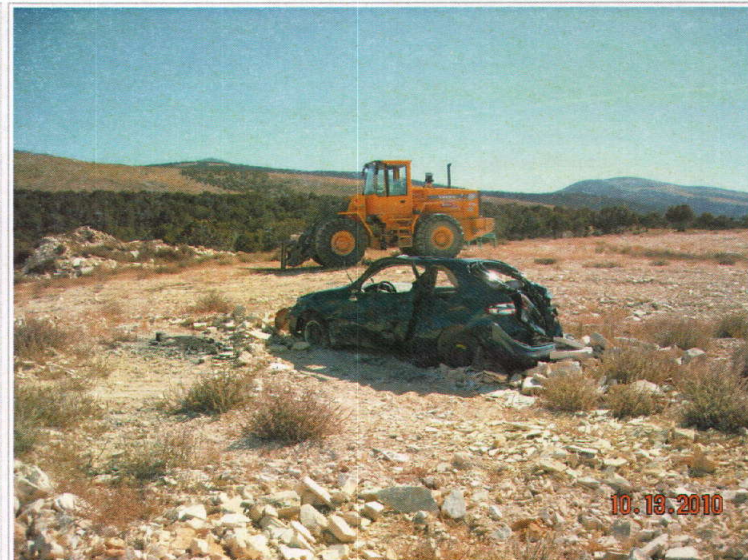
Car wreckage needs to be removed to a landfill.

1. The mining permit is no longer valid when the mineral lease is expired.
4. The car wreckage needs to be removed off the site to a local landfill.
10. The operator should broadcast seed over the entire site early before the surface hardens and the winter season begins.

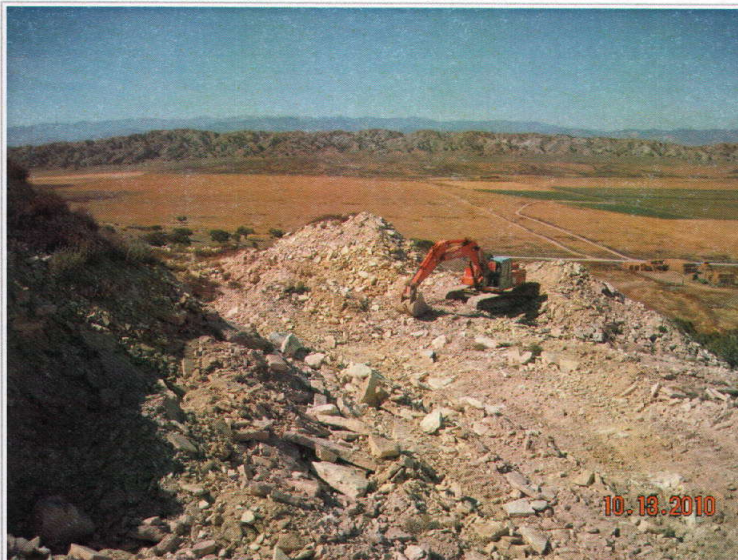
Equipment and unreclaimed surface disturbance.

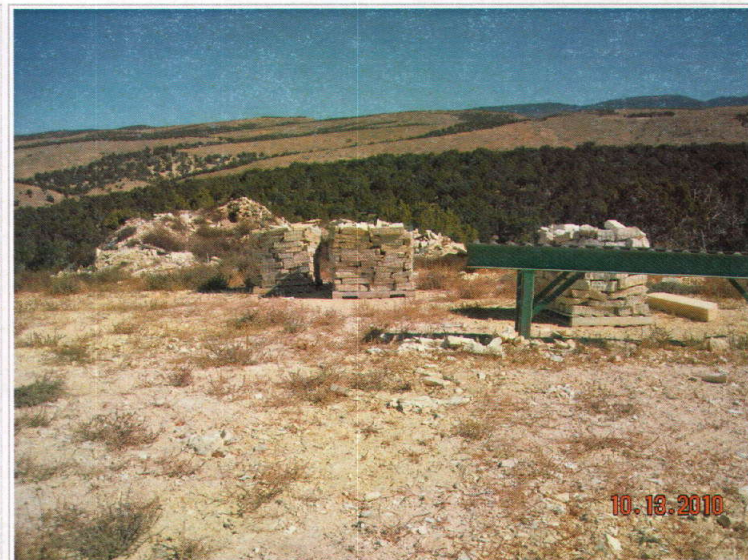
Palettes of limestone etc. that need to be removed!

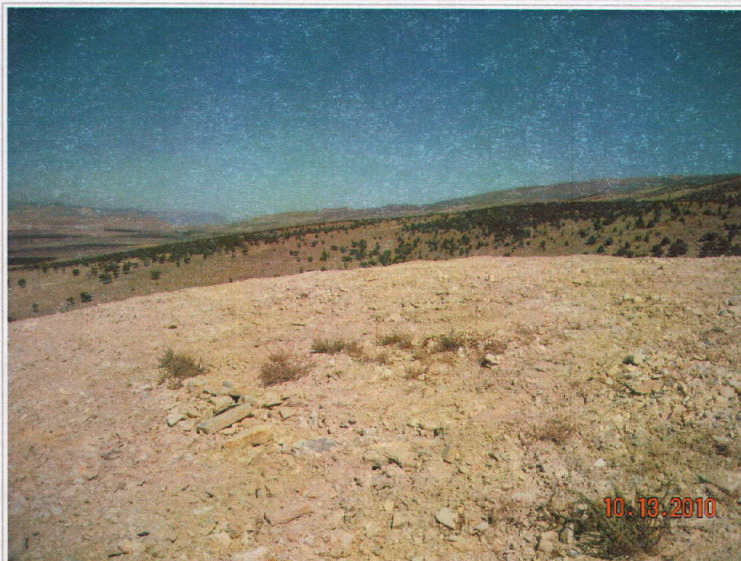
View of regraded surface.

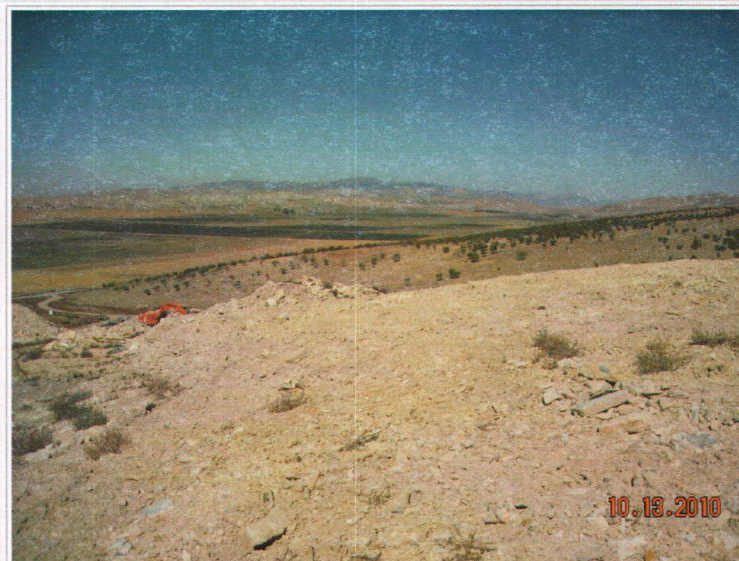
View of regraded surface.

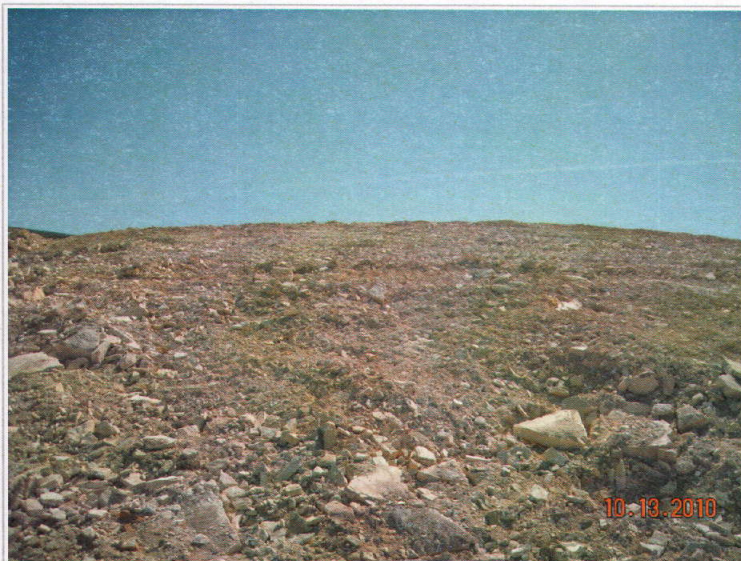
View of regraded surface.

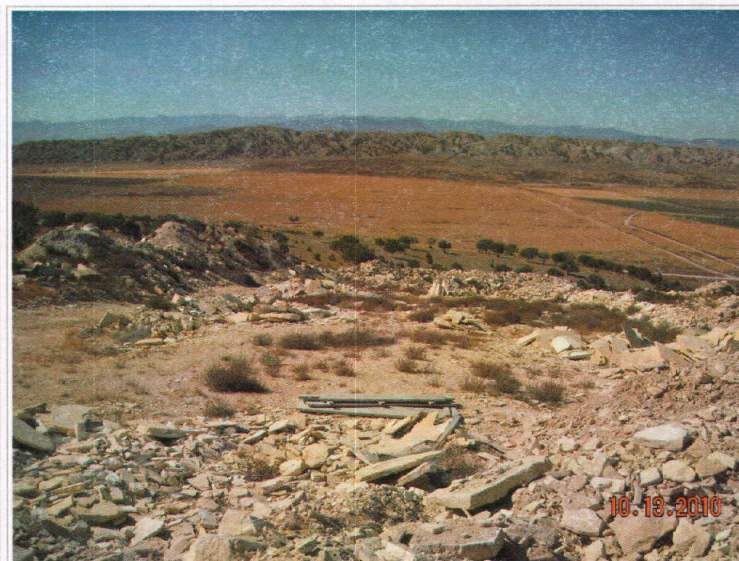
Unreclaimed surface disturbance.

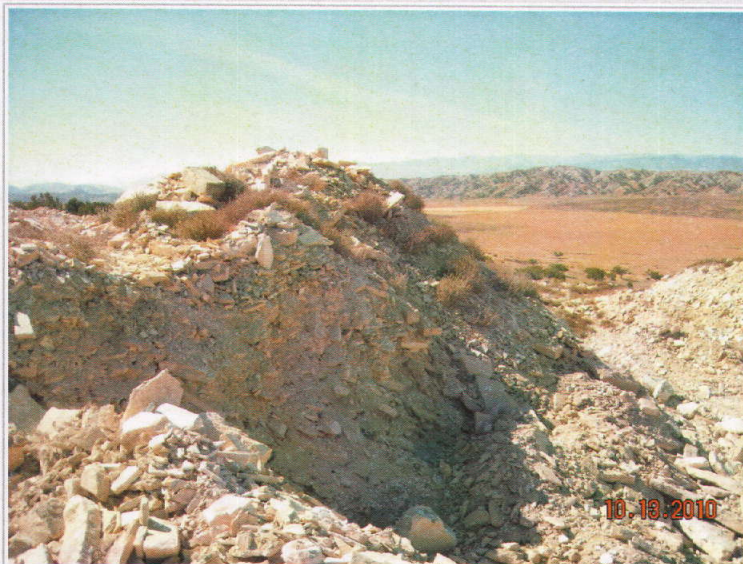
Lower hillside disturbance that needs to be reclaimed.

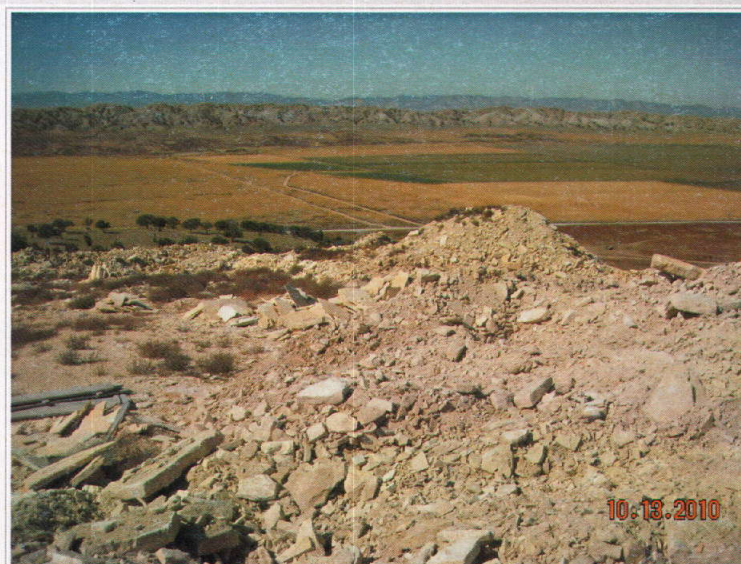
Lower hillside disturbance that needs to be reclaimed.

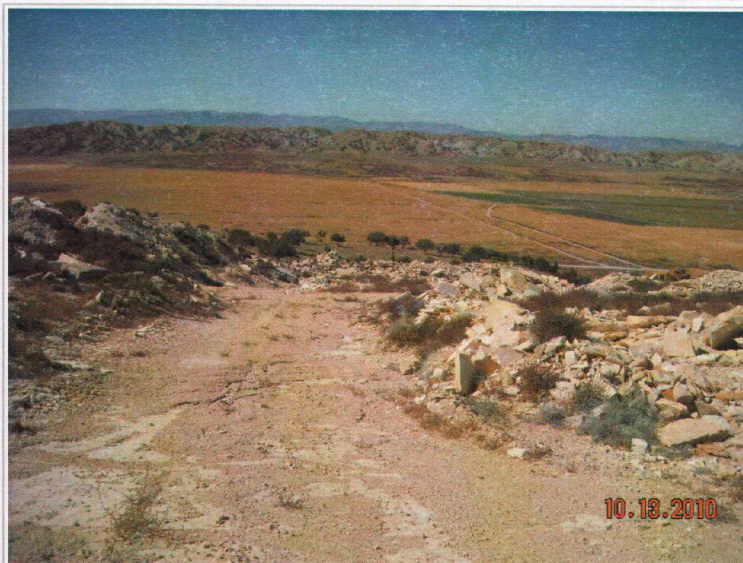
Road reclamation needed.

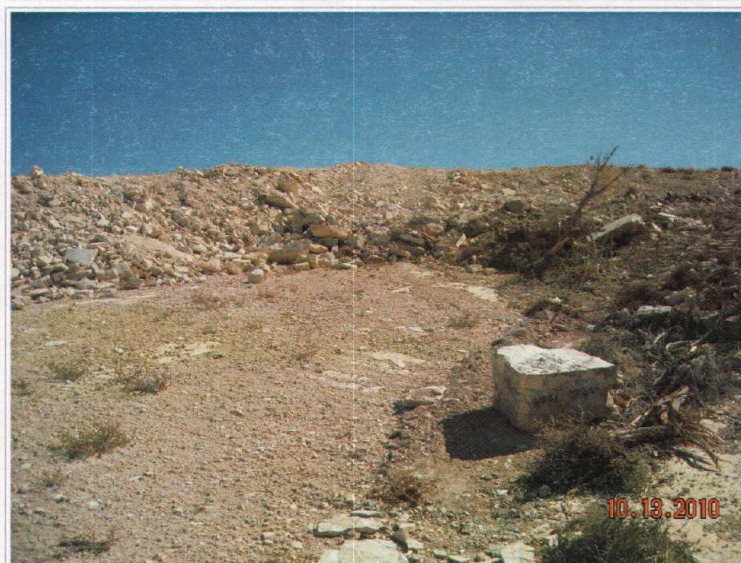
Termination point of the upper regraded disturbance.
